Avoidance & Minimization – Hartland Phase II

JOINT PERMIT APPLICATION

HARTLAND PHASE II

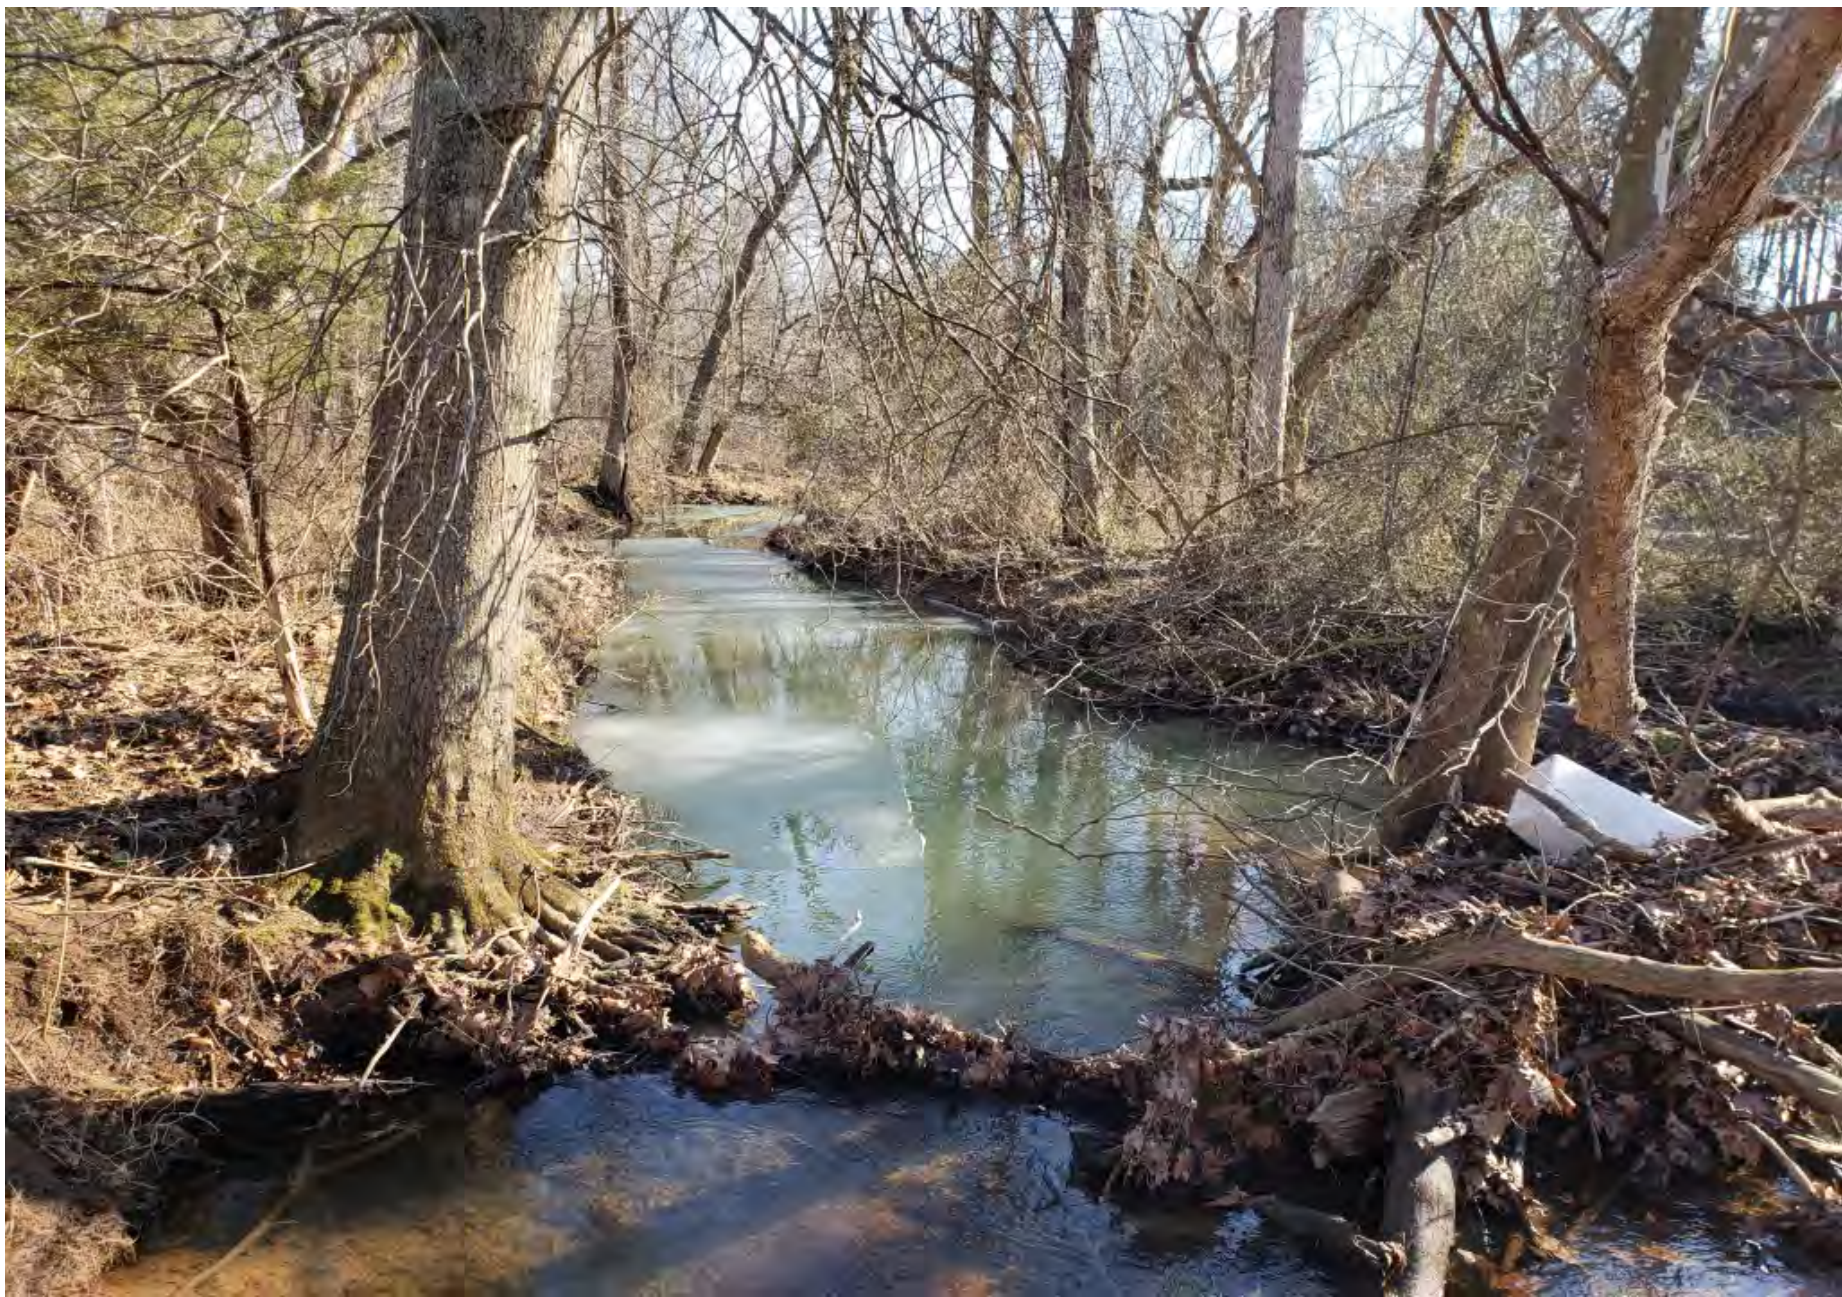
Downstream view

Pier installation for northern bridge crossing.

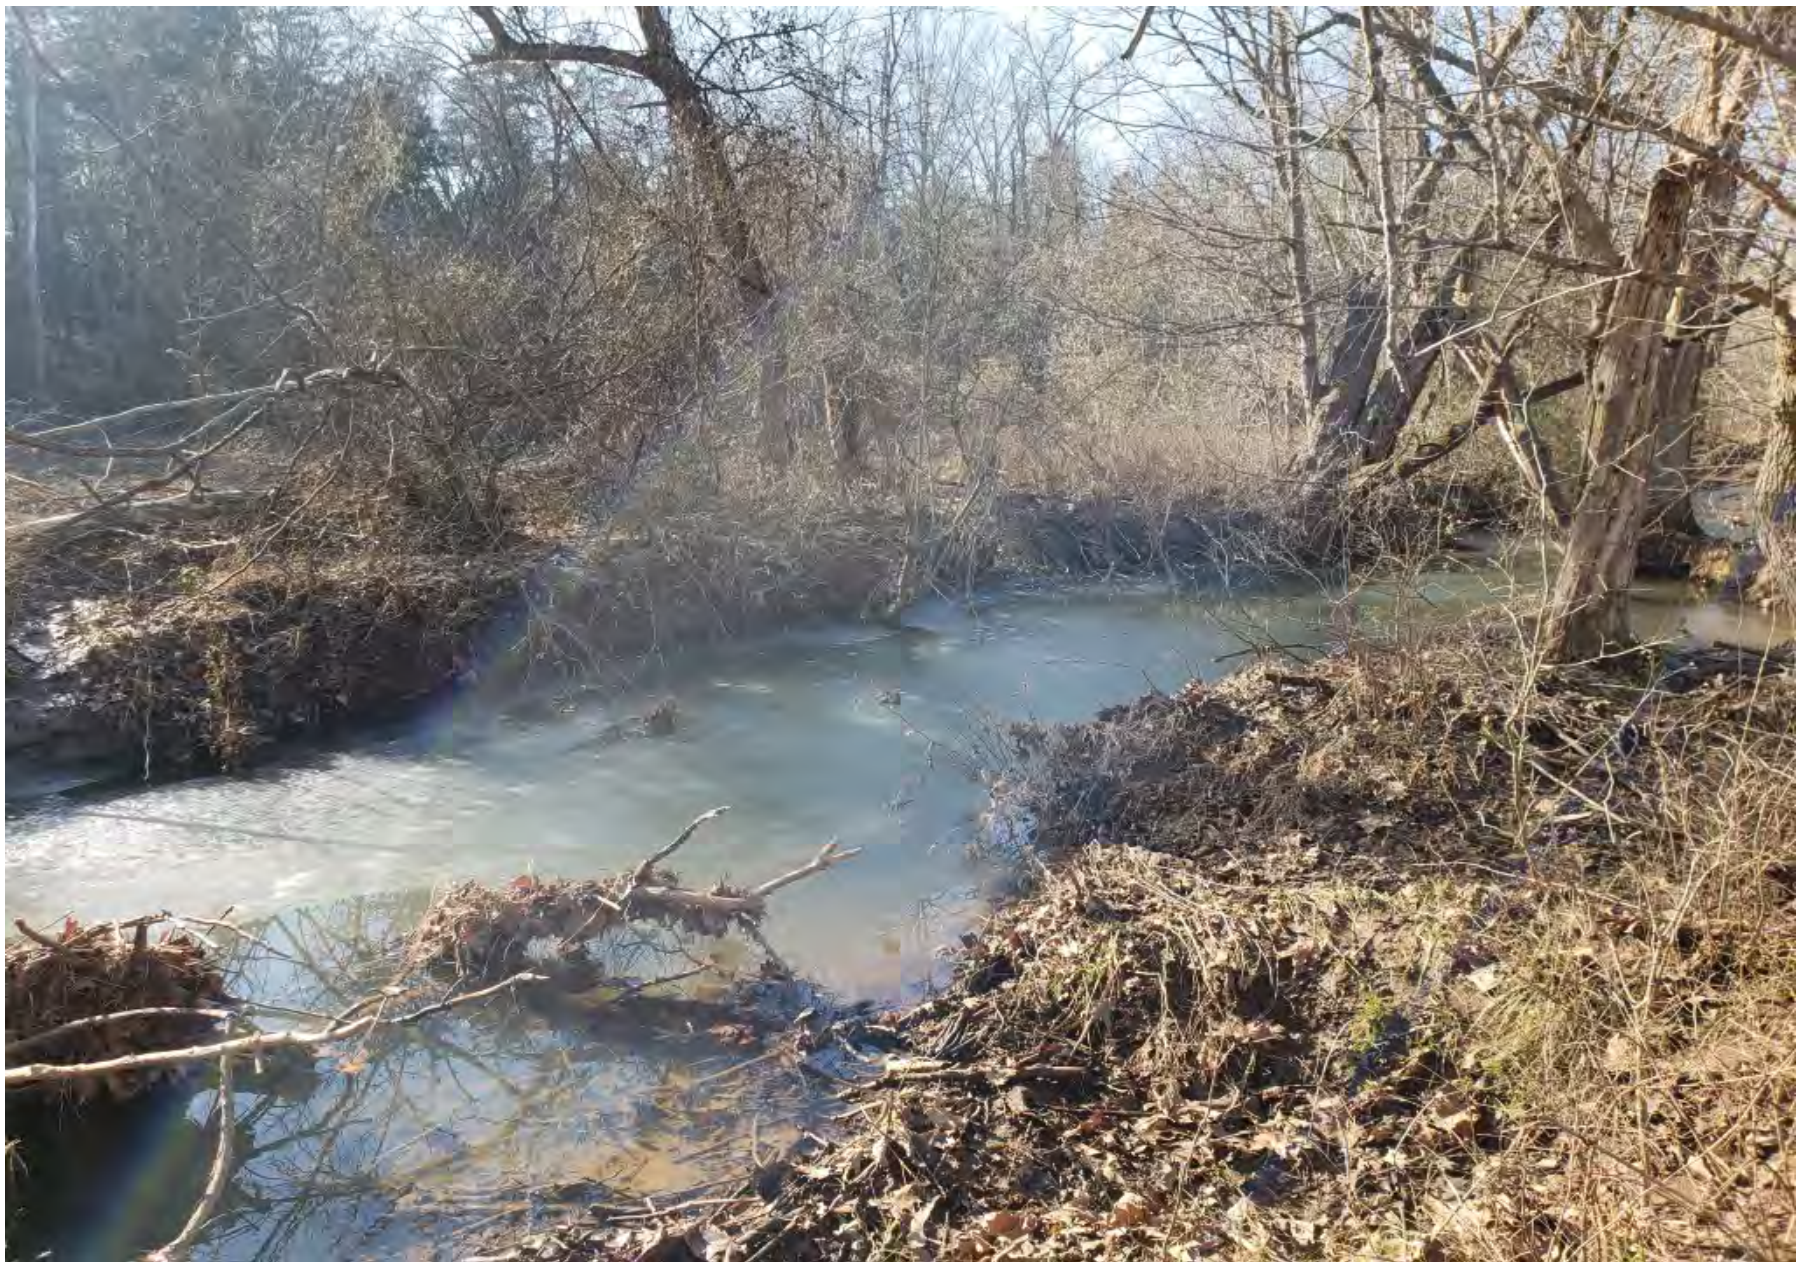
Upstream view

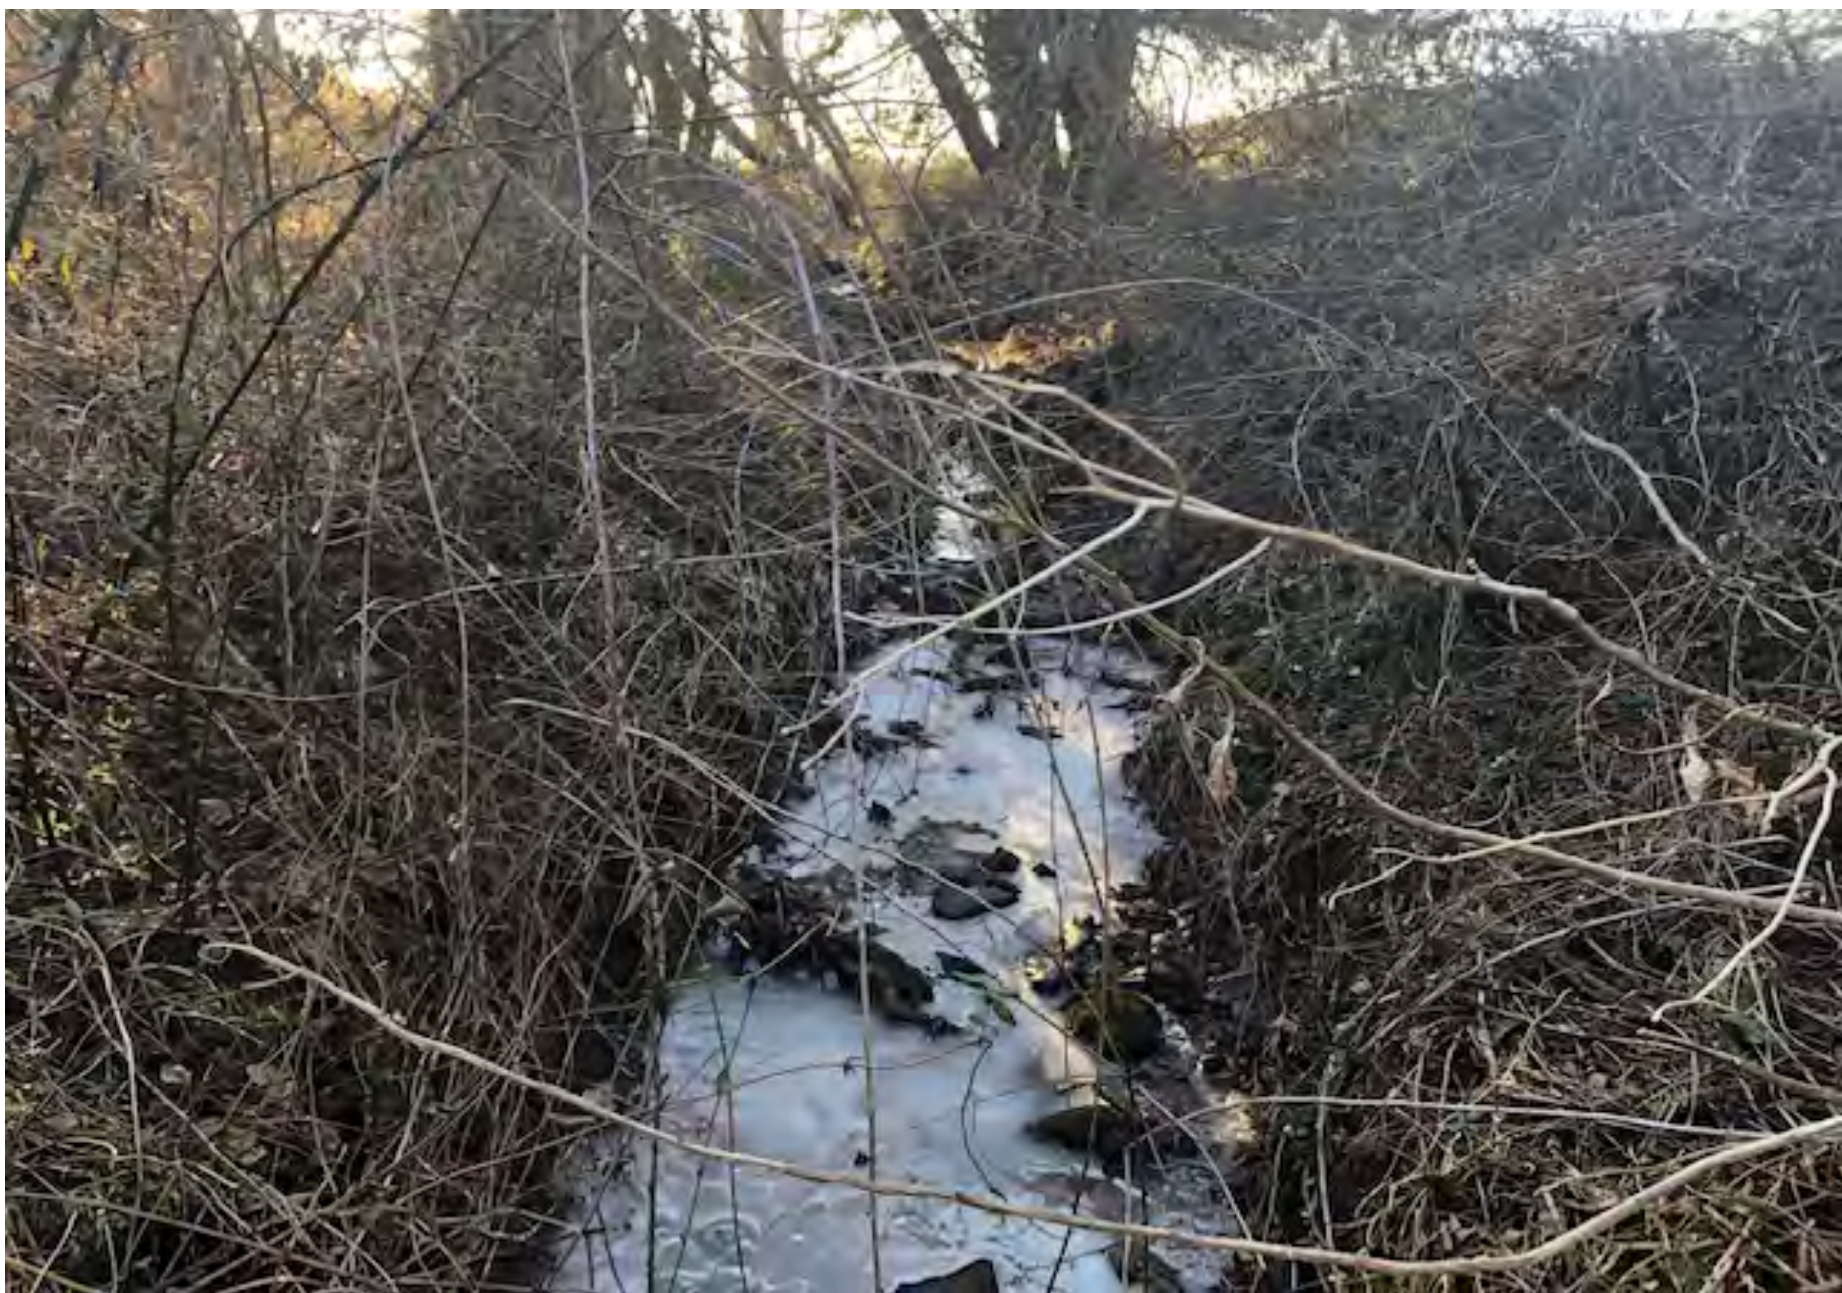
Upstream view

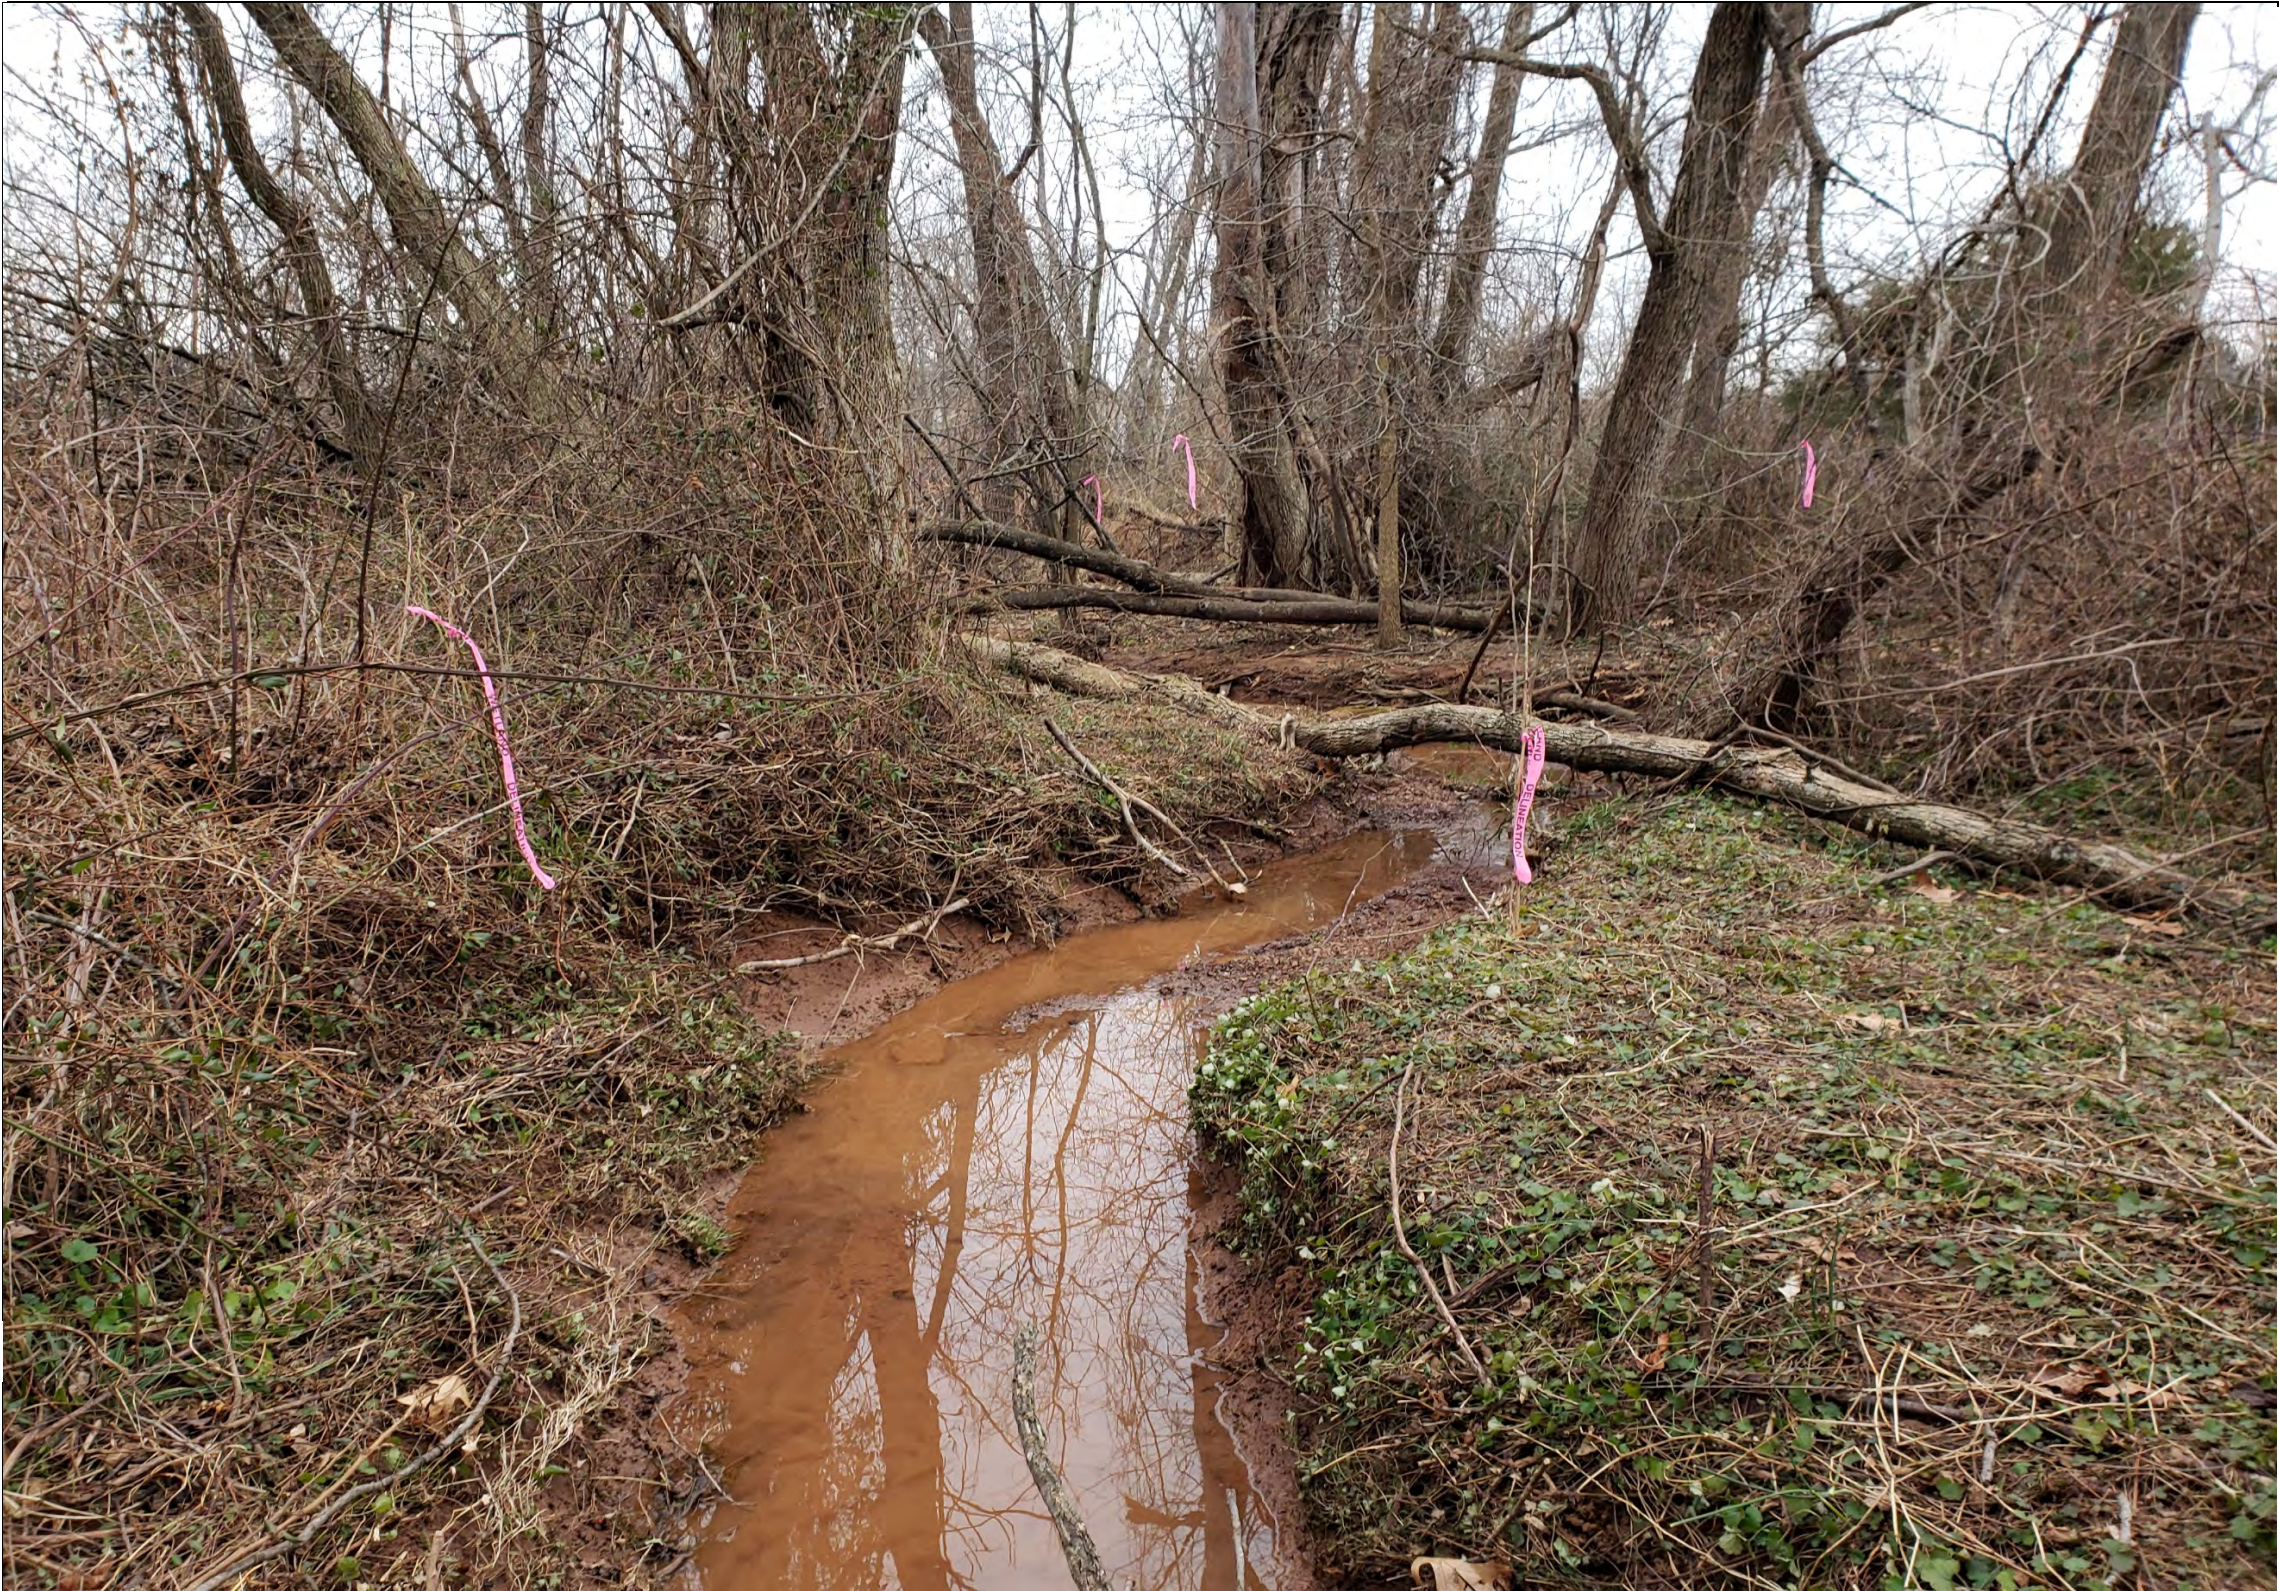
Score	3	2.4		2		1.6		1		
NOTES>>	Partially incised stream with vegetative cover on 60% of banks. Erosion visible on 50% of stream banks.									
2. RIPARIAN BUFFERS: Assess both bank's 100 foot riparian areas along the entire SAR. (rough measurements of length & width may be acceptable)										
Conditional Category										
Riparian Buffers	Optimal	Suboptimal		Marginal		Poor		NOTES>> Both stream banks consist of suboptimal forest cover and actively grazed pasture.		
	Tree stratum (dbh > 3 inches) present, with > 60% tree canopy cover and a non-maintained understory. Wetlands located within the riparian areas.	High Suboptimal: Riparian areas with tree stratum (dbh > 3 inches) present, with 30% to 60% tree canopy cover and containing both herbaceous and shrub layers or a non-maintained understory.	Low Suboptimal: Riparian areas with tree stratum (dbh > 3 inches) present, with > 30% tree canopy cover and a maintained understory. Recent cutover (dense vegetation).	High Marginal: Non-maintained, dense herbaceous vegetation with either a shrub layer or a tree layer (dbh > 3 inches) present, with <30% tree canopy cover.	Low Marginal: Non-maintained, dense herbaceous vegetation, riparian areas lacking shrub and tree stratum, hay production, ponds, open water. If present, tree stratum (dbh >3 inches) present, with <30% tree canopy cover with maintained understory.	High Poor: Lawns, mowed, and maintained areas, nurseries; no-till cropland; actively grazed pasture, sparsely vegetated non-maintained area, recently seeded and stabilized, or other comparable condition.	Low Poor: Impervious surfaces, mine spoil lands, denuded surfaces, row crops, active feed lots, trails, or other comparable conditions.

Downstream view

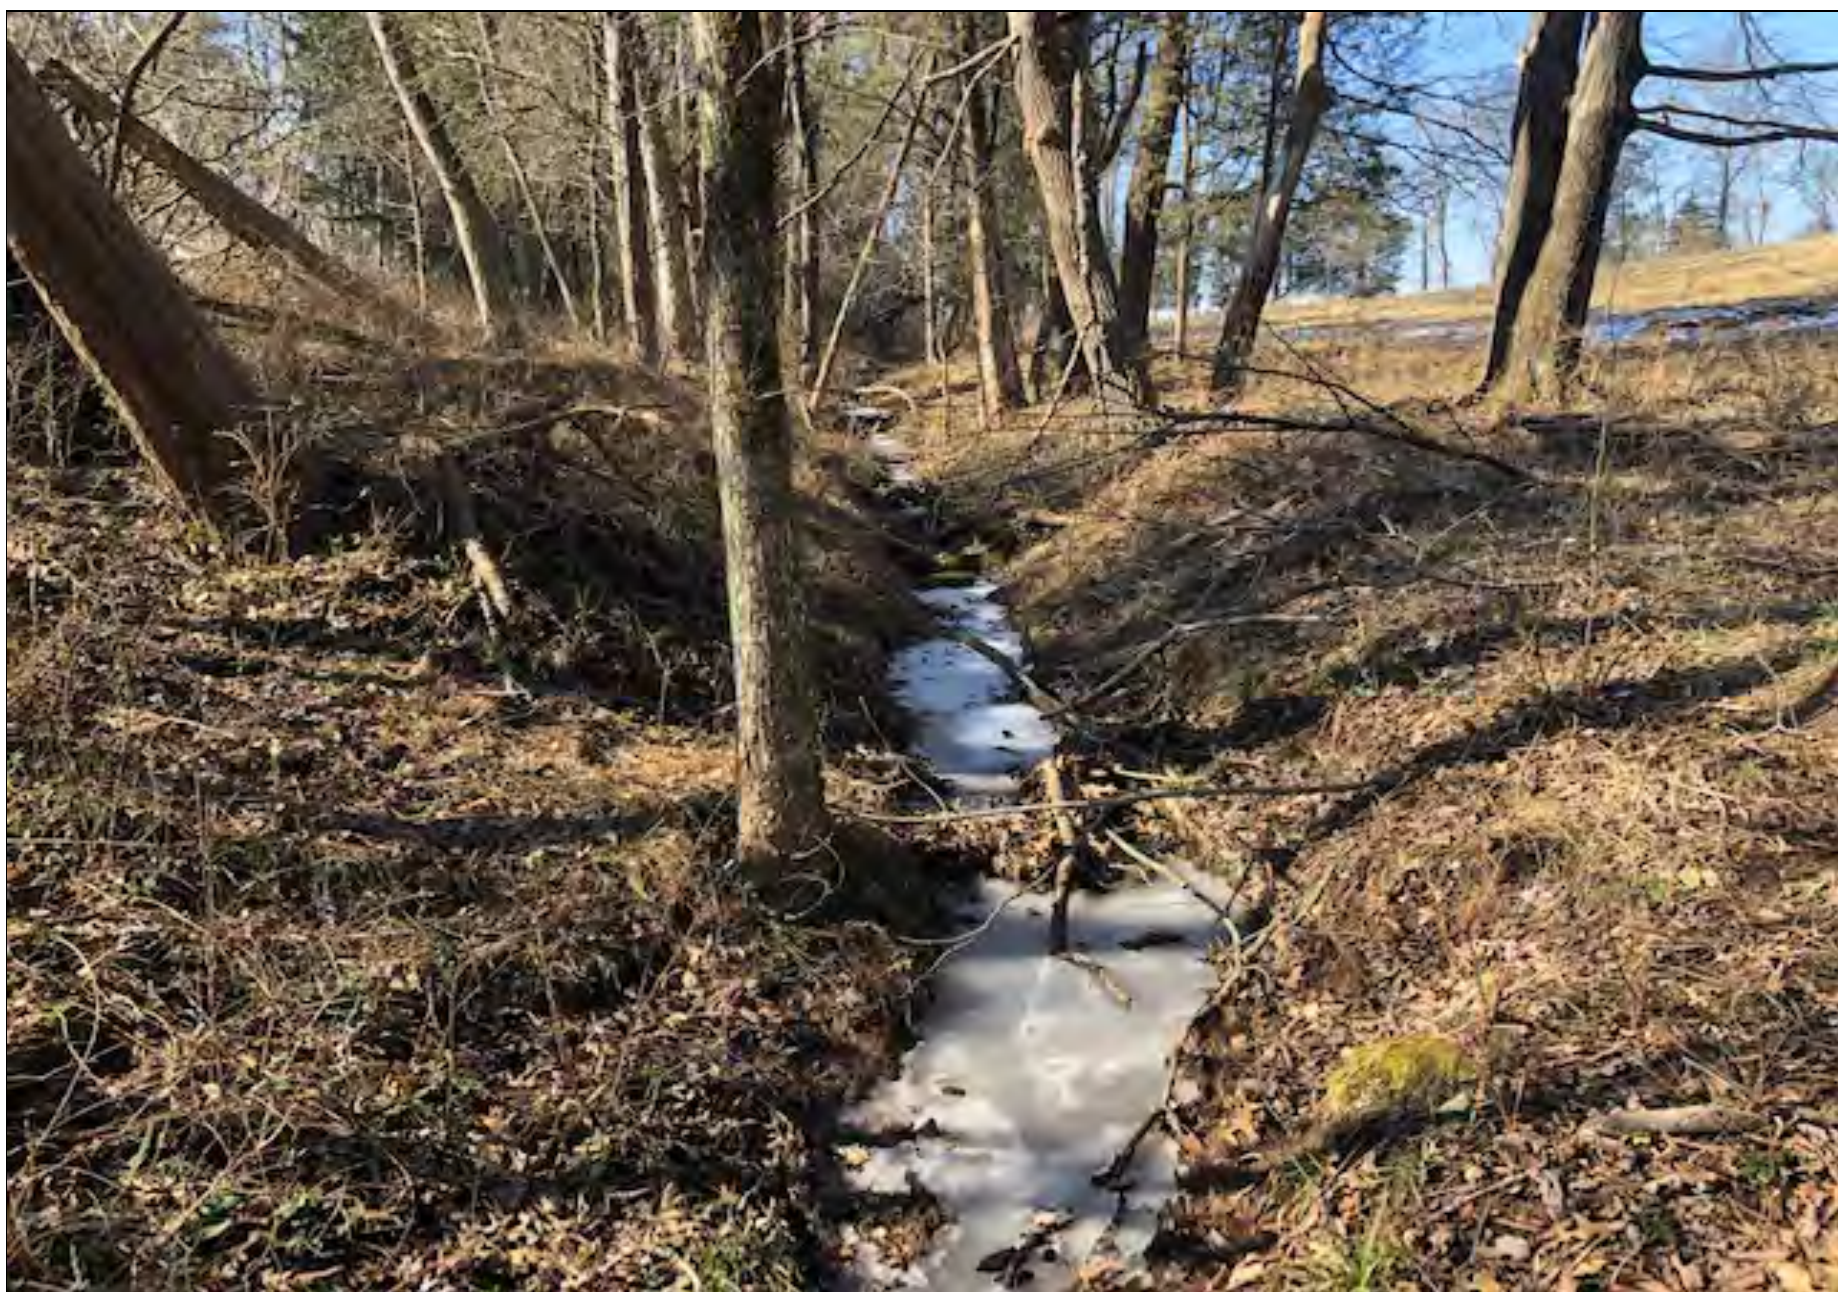
Upstream View

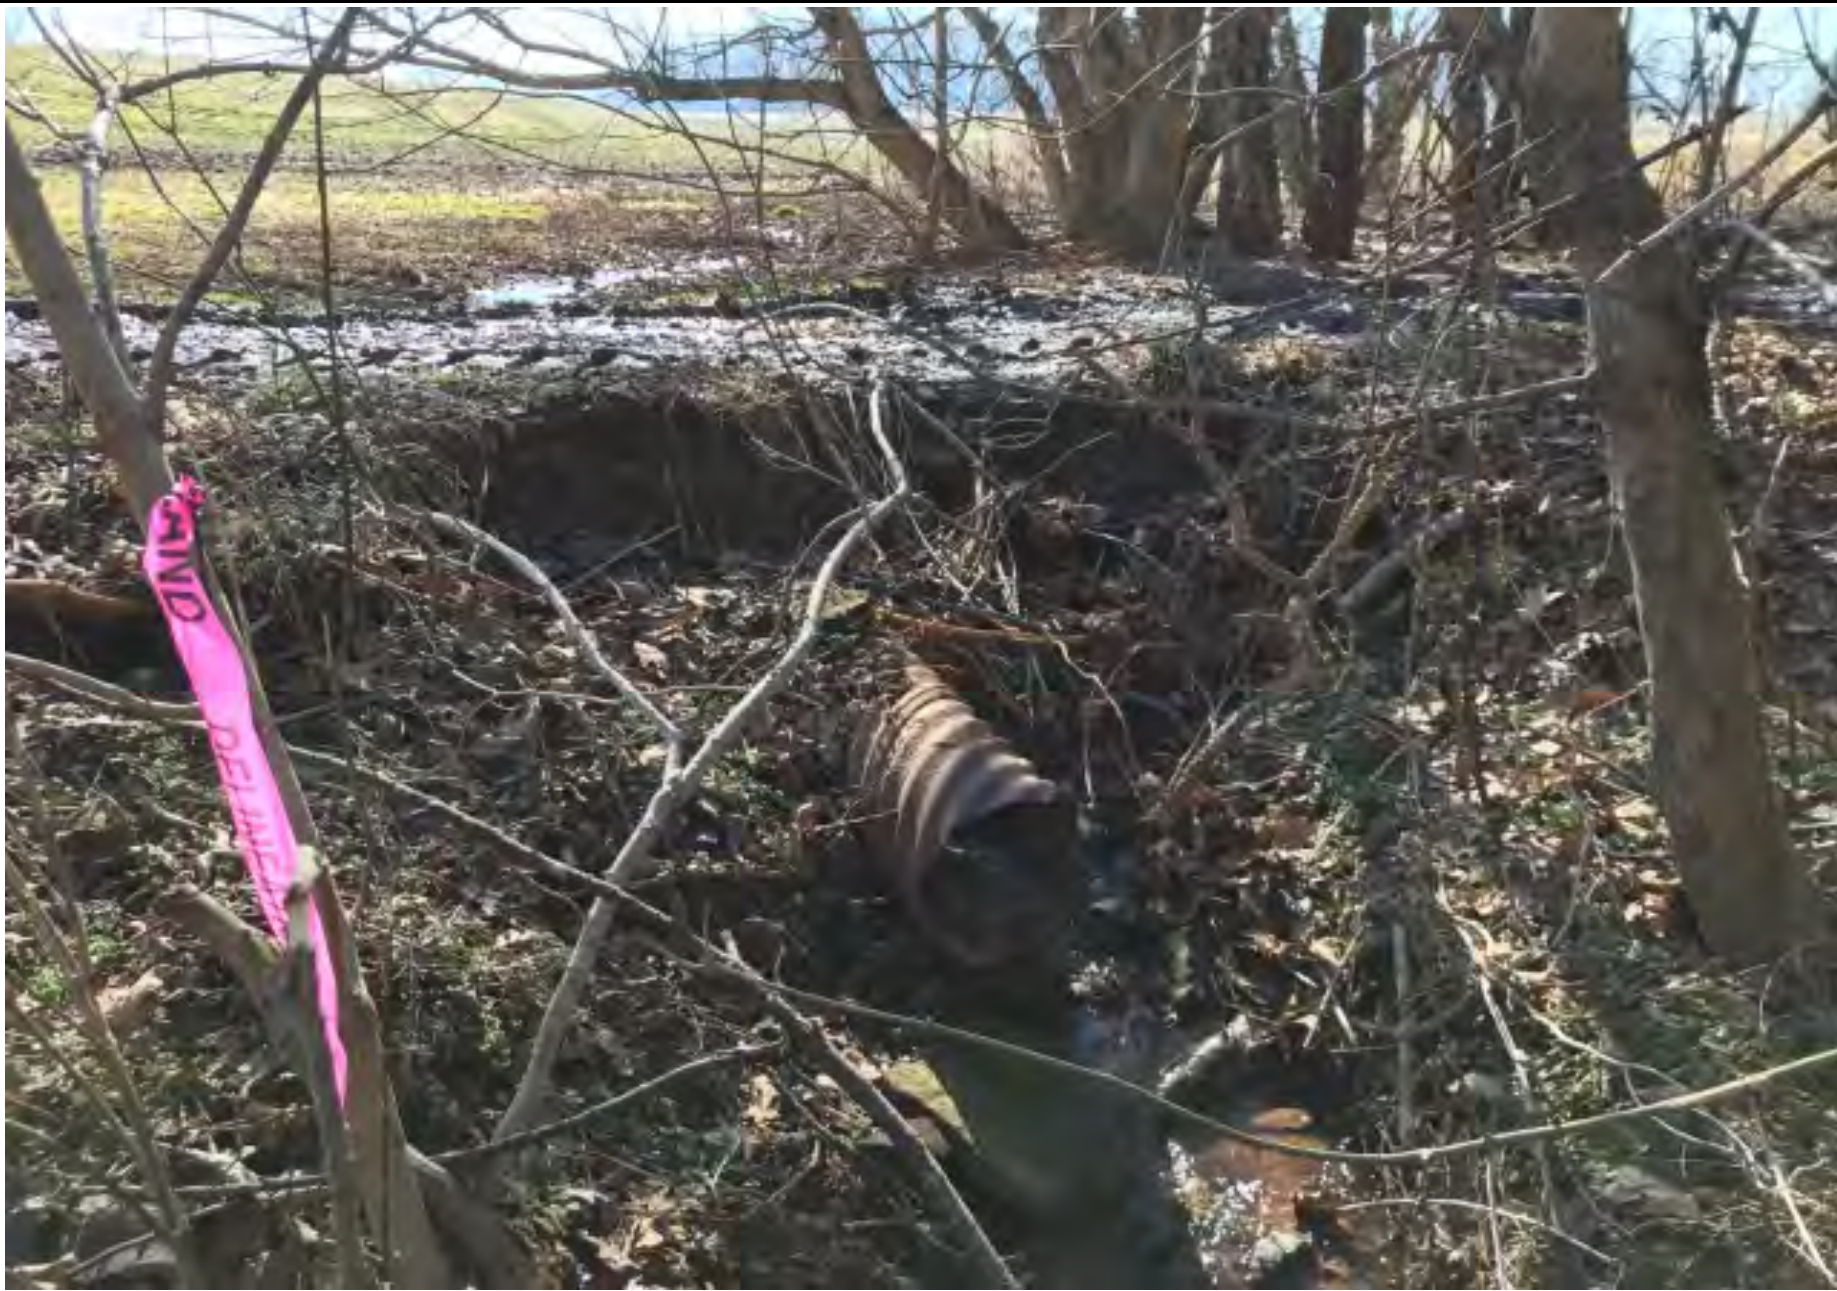
Upstream View

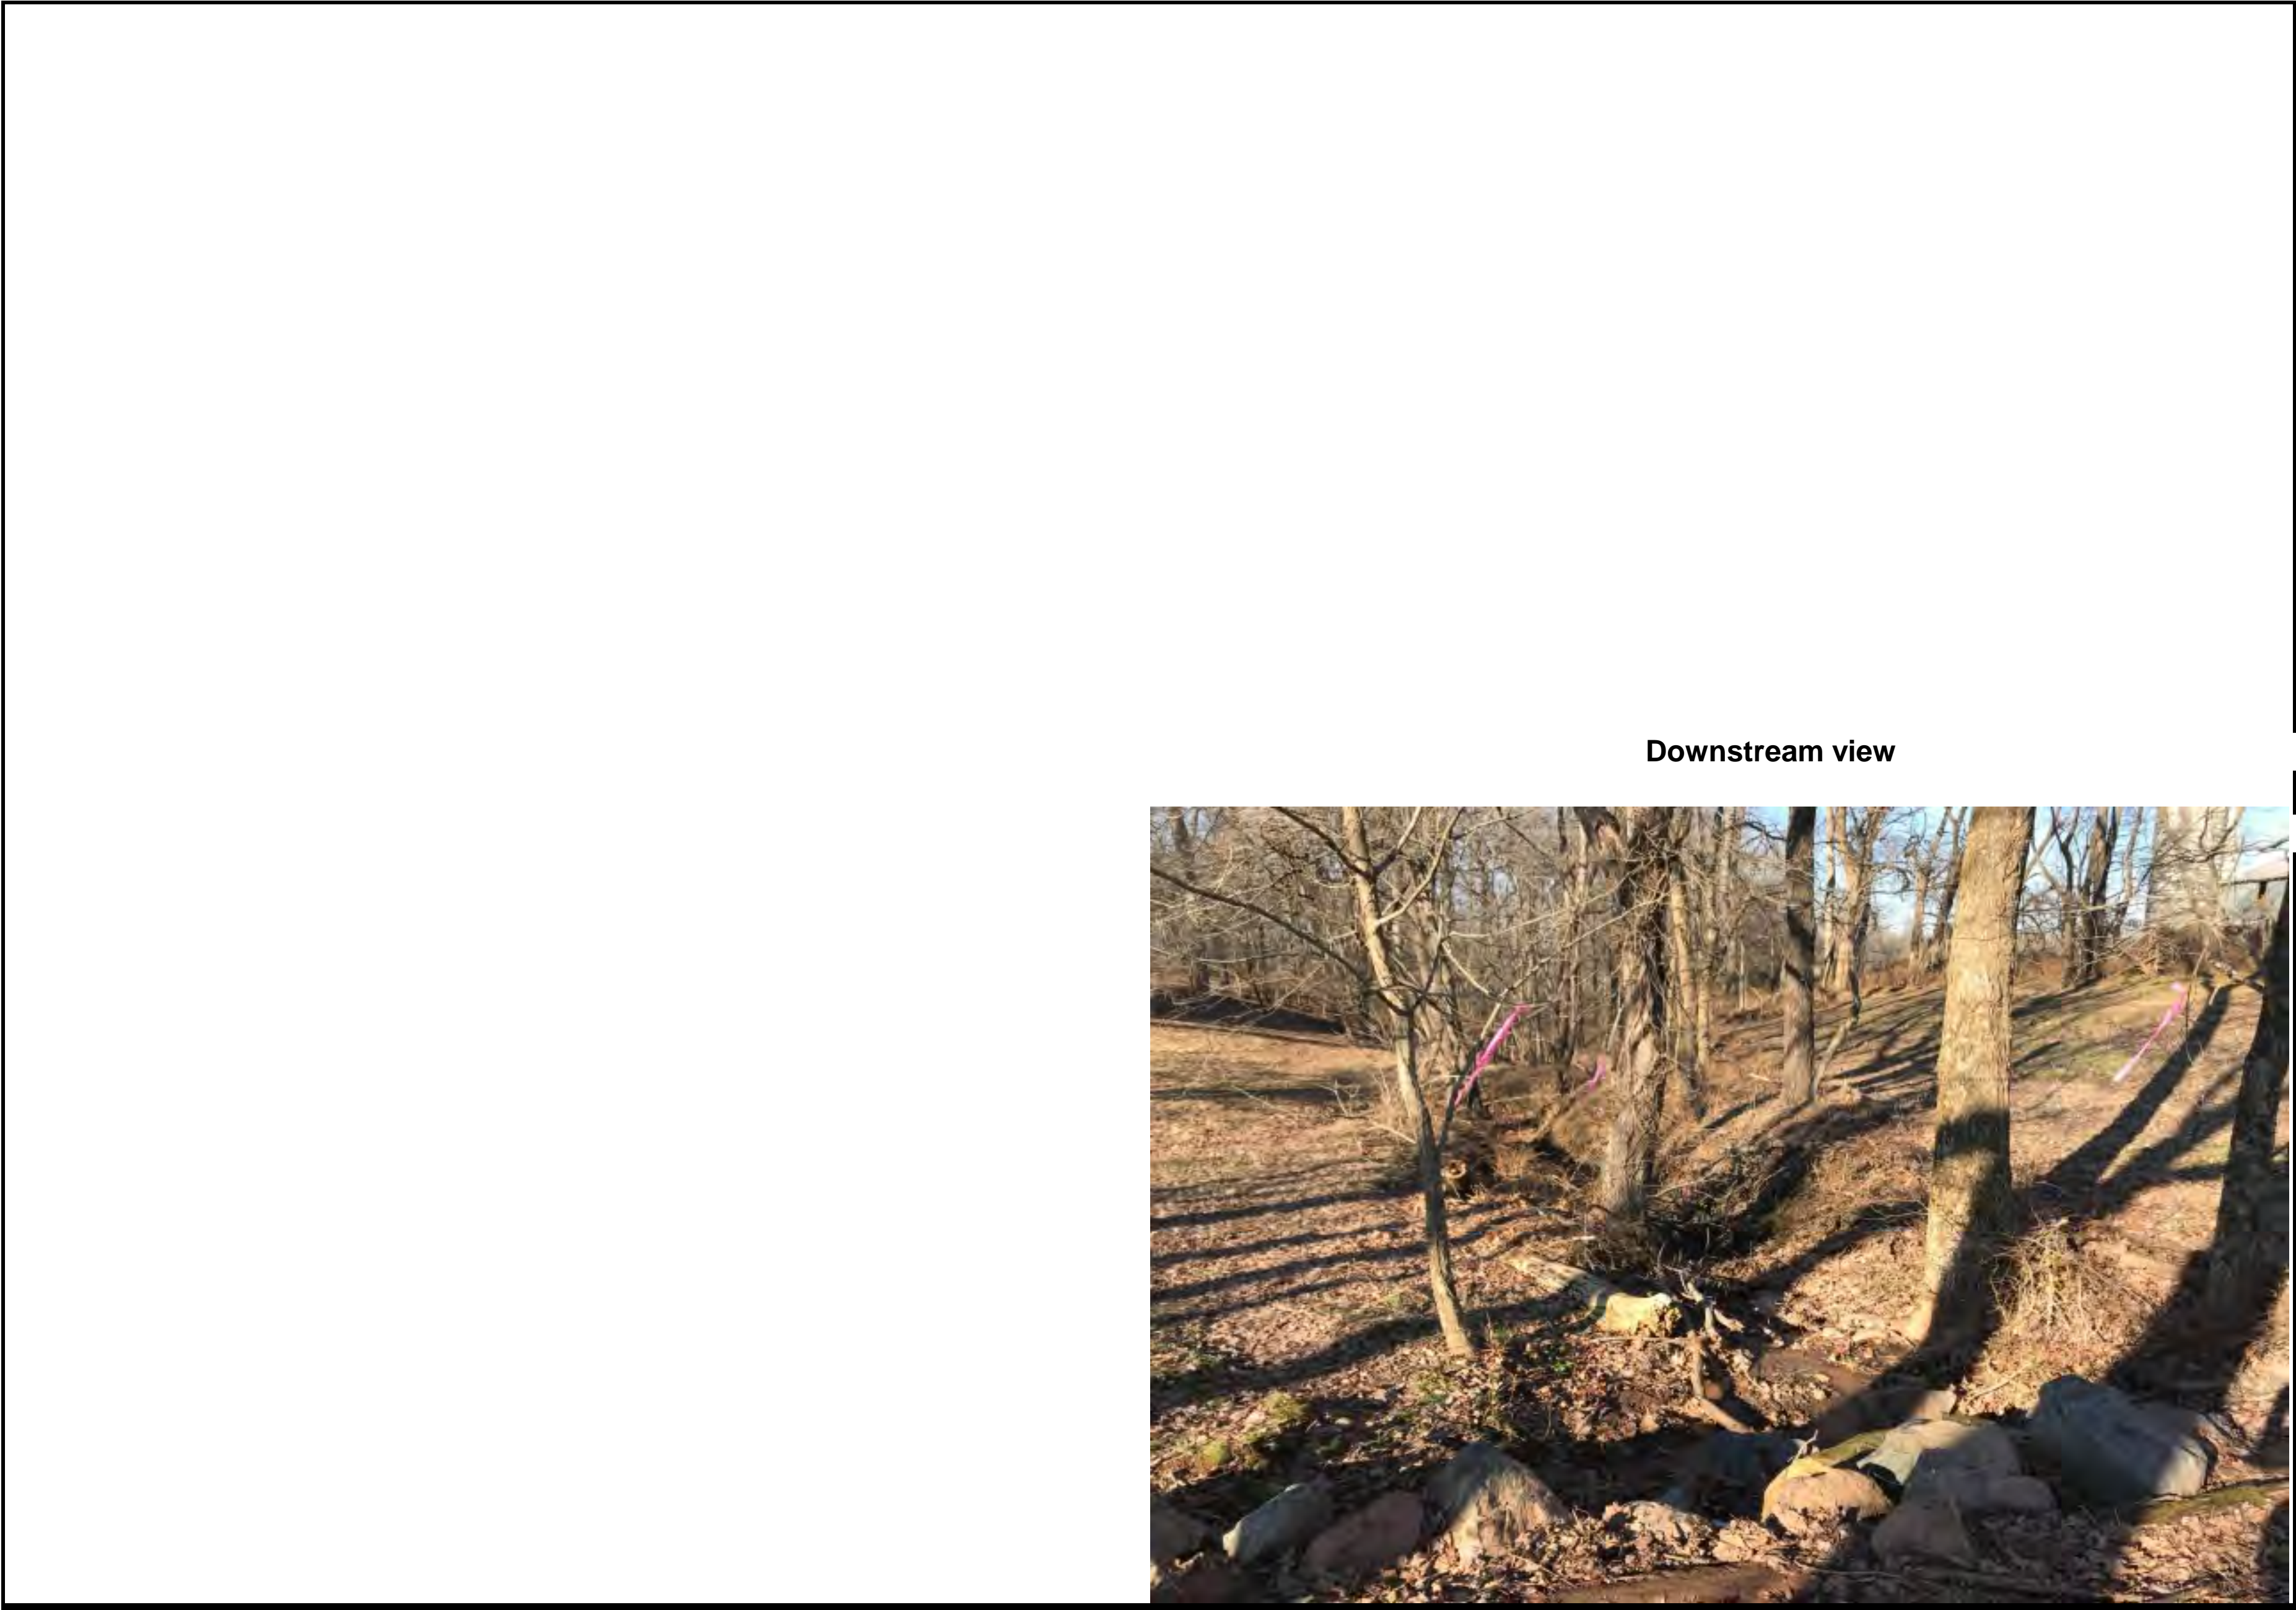
Grading associated with the installation of road access to stormwater management pond F-3.
